International Conference on Industrial Engineering, ICIE 2016

## Reasons for Exterior Effective Brick Walls Deterioration as Exemplified with Buildings under Construction

This article discusses the problem related to the appearance of defects in masonry cladding layer of self-supporting walls of buildings with monolithic concrete frame as exemplified with the inspection of buildings under construction in the residential quarters of "October" district of Novocherkassk. As a result of the survey by OOO "SPU" specific defects in the self-supporting layer of facing walls of buildings were identified and described and their causes were identified. Based on the existing expertise, instrumental testing of the construction materials, conducted by a certified testing laboratory, the survey materials present an overview of the causes for the identified defects as studied by other professionals and organizations, one of the leading of which is CNIISK. VA Kucherenko. Based on the results of the systematic analysis of the detected defects and instrumental research data the authors proposed several solutions aimed at eliminating the defects and bringing the building up to the standard.

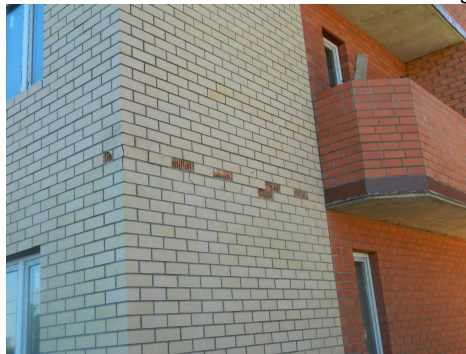
- detachment of the decorative layer of brickwork in the level of floor slab (1st to 6th floors) (Fig. 2).
- vertical and inclined cracks in various areas of external masonry walls of buildings opening width of 0.5 mm to 3 mm (Fig. 3).

Fig. 2. Destruction of material masonry facade wall in the overlap level

The reason for the destruction of the surface layer of bricks in the level of overlap is no horizontal joints, provided the requirements of [18], intended to compensate for the difference between the vertical deformation of the outer and inner layers of the outer walls, floors sag, as well as the building frame. According to para. 9.83 [18] horizontal expansion joints in exterior curtain walls must be carried out at the lower edge of interfloor slabs the entire thickness of the wall at least 30 mm thick.

However, guidance on the device of horizontal seams project were not provided. Due to the fact that the horizontal joints in the brickwork buildings surveyed no load on masonry floors summarized as its location relative to the above positioned.

The results of the testing calculations found that the brickwork of the lower floors of buildings housing complex is located in a congested state, which led to the destruction of materials masonry walls in local areas first six floors.

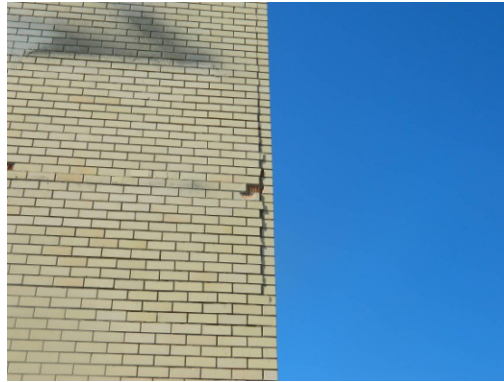
Fig. 3. The vertical crack opening width up to 3 mm wall facade. The destruction of brick material

With regard to education and disclosure of vertical and inclined cracks in the facial layer of masonry, then there is a lack of vertical joints to compensate for temperature and humidity strains, exacerbated by the lack of horizontal joints. According to [18] in the facial layer of lightweight masonry exterior walls based on temperature and humidity impact the vertical expansion joints must be provided. Device vertical joints was also not provided by design.

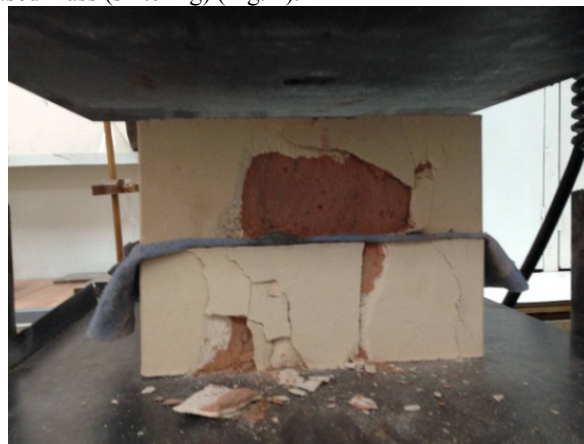
It is also one of the causes of destruction of brick face layer is a discrepancy between the strength characteristics bricks of "KERAMIN" stated performance characteristics. According to the results of laboratory tests of samples of ceramic bricks facial hollow thickened KULPu-1,4NF/150/1.2/50 GOST 530/2007, as determined by the [19, 20] in the Institute of Construction Technology Laboratory "Building technologies" YURGPU (NPI) name MI Platova its mark on the compressive strength corresponds stamp M100 GOST 530-2012, which corresponds to the design solutions, however, during the test brick compressive strength under a load of 2.0 MPa was observed destruction engobe layer and its peeling, while maintaining the integrity of the main body of bricks. This indicates a sharp contrast to the strength properties of the crock and its actual brick facing layer (engobe) due to differences of technological properties of the used mass (sintering) (Fig. 4).

Fig. 4. Laboratory tests of strength of bricks. The destruction of the facing layer by application of a load of 2.0 MPa
